**EXECUTIVE SUMMARY
FOR
CASPER ALCOVA IRRIGATION DISTRICT
GIS PROJECT, LEVEL II STUDY**

*Anderson Consulting Engineers, Inc.
772 Whalers Way, Suite 200
Fort Collins, CO 80525
(ACE Project No. WYWDC24)*

January 4, 2008

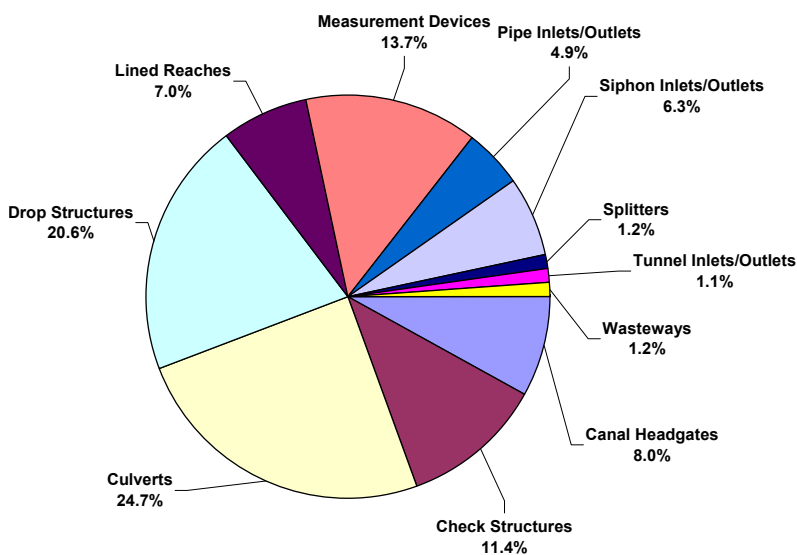
The CAID distribution system was inventoried during the non-irrigation season beginning in the Fall of 2006 and ending in the Spring of 2007. Over 1,500 structures and features were inventoried and evaluated during this phase of the project. Table 1 summarizes the numbers of structures and their condition inventoried within the CAID system. Figure 1 summarizes the relative distribution of different types of conveyance structures in the CAID. This figure omits the individual farm turnouts, bridges, channel features (erosion, sedimentation, etc.), and miscellaneous crossings (utilities, water lines, etc.).

Figure 1. Relative Distribution of Conveyance Structure Types within the CAID.

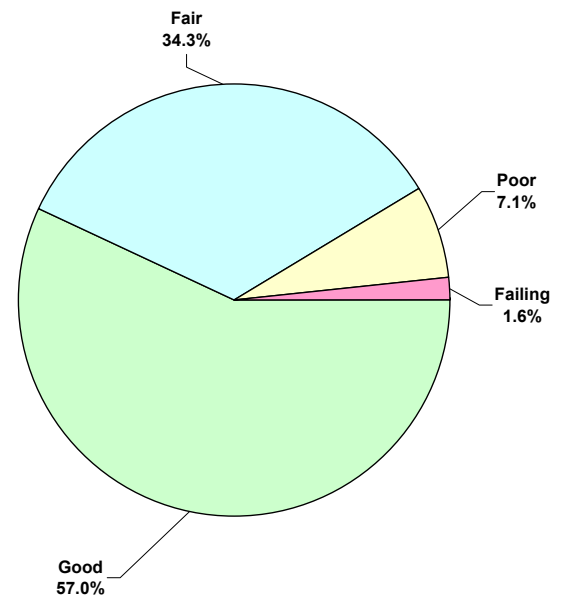
For every conveyance structure inventoried, field crews assigned an overall condition ranging from “failing” to “good”. This information is summarized in Figure 2. As displayed in this figure, the majority of structures were classified as being in ‘good’ or ‘fair’ condition. Only 7.1 percent of the conveyance structures inventories were classified as being in ‘poor’ condition and 1.6 percent as ‘failing’. These percentages, while relatively low in magnitude, represent a total of approximately 94 structures (77 poor and 17 failing).

As indicated in Figure 2, nearly 8.7 percent of the structures inventoried in the CAID system were rated as either “poor” or “failing” condition. Replacement is recommended for all failing structures. Poor structures, on the other hand, were often earmarked for partial rehabilitation at significantly lower costs.

Figure 2. Relative Distribution of Overall Condition: CAID Canal/Lateral System.
