This Creek Care Guide is a educational component of the Garden Creek Stream Restoration Demonstration Project, funded by the City of Casper with a grant from the Wyoming Department of Environmental Quality/U.S. Environmental Protection Agency. The objective of the Project was to restore and stabilize 2,000 feet of Garden Creek through Nancy English Park.

The restoration project was designed to reduce creek bank erosion and excess sediment in this portion of Garden Creek, restore the riparian corridor to increase natural habitat for birds and wildlife, and to serve as a dynamic demonstration platform for good creek care stewardship. This companion Creek Care Guide was developed to encourage and support ongoing stewardship of all waterways in the Casper Mountain Watershed.

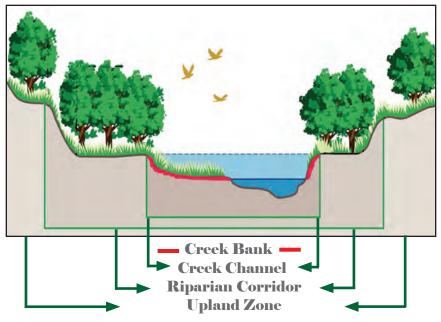
# **COMPONENTS OF A WATERWAY**

While each creek, stream, and river has unique characteristics, all healthy waterways have the same fundamental components. In addition to a riparian corridor, there is a defined creek channel; the area of the riparian corridor that periodically or continually contains flowing water. The creek bed, or bottom, is composed of a mixture of gravel and sand with a limited amount of silt and sediment. The riparian area is free of trash and debris.

The sloping area between the water's edge and level ground is referred to as the creek bank or stream bank. Roots and spill-over vegetation from the riparian corridor help to stabilize the stream banks, filter sediment, and is critical in reducing soil erosion during seasonal runoff and high water events.

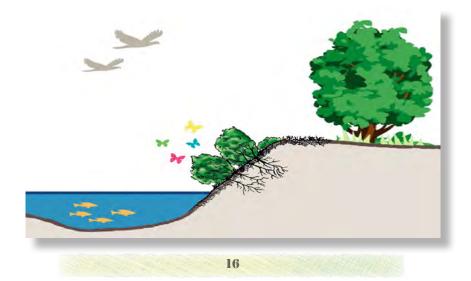
Modify steep banks to shallow or moderate slopes and re-vegetate with native riparian species. Live cuttings of willow or cottonwood driven into the bank, or bundles of live cuttings secured to the bank can be effective stabilization techniques. Cuttings should be harvested after dormancy in the fall and before bud break in the spring. They will remain dormant if stored in a cool dry place until planting season. Harvest willow cuttings long enough to extend at least 8 inches into the water table and 8-12 inches above the ground when planted.

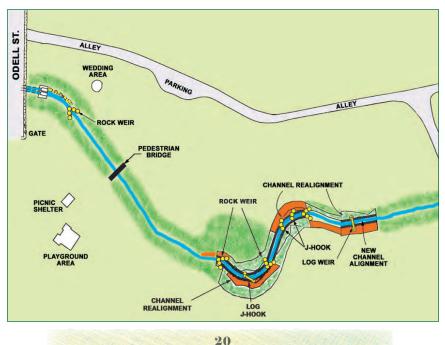
Prior to restoration, Garden Creek through Nancy English Park was characterized by many of the signs of a stressed or unhealthy waterway. Severe bank erosion and under-cuts increased sediment in the water and creek bed. The riparian buffer was thin, dominated by non-native vegetation and nonexistent vegetation. Trash and debris in the creek bed and along the creek banks was common. Throughout most of the year water temperatures were high due to reduced, shallow water flow. Ongoing water sampling indicated persistent high levels of pollutants such as fecal coliform.

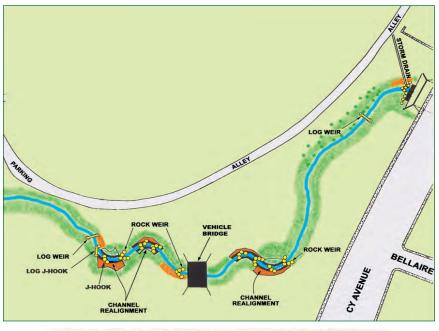
The creek banks were sloped back in open areas and a landscaping (no-mow) buffer zone was created and defined. Debris, non-salvageable and invasive vegetation were removed. The creek channel was realigned at specific points where severe erosion had influenced the direction of the water flow. Rocks and logs were carefully placed to reinforce the creek banks, redirect the water flow to reduce future bank erosion, and to create faster moving riffles and quiet pools.
